Immersion Ultrasonic
imaging of Connecting
rod small end bush
interface
A Dhvani
Research Application
Note

NDT OF AUTOMOBILE COMPONENTS

NON-CONTACT WATER COUPLED ULTRASOUND NDT SOLUTION

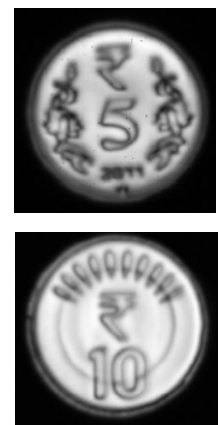
IMMERSION SCANNING UT IMAGES

The image shown below is of an immersion scanning carried out on a 5 rupee and 10 rupee coin using a 15 Mhz transducer in pulse echo mode. The image plotted is a front wall gated C Scan
