# DEFECT DETECTABILITY IN CAST IRON GRADES USING IMMERSION ULTRASONIC TESTING METHOD

# Defect Detectability in Cast Iron Grades using Immersion Ultrasonic testing - Application Note

A Dhvani Research  
Application Note

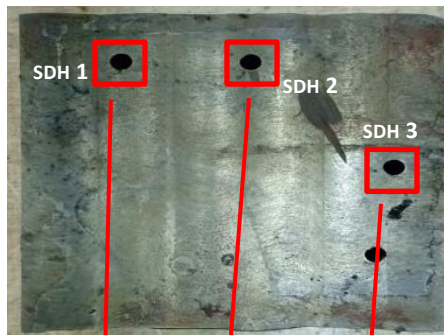
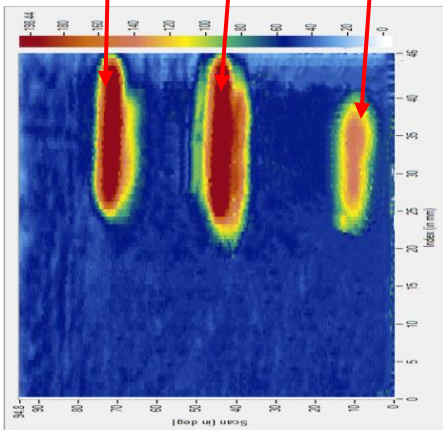
Sample with SDHs:

Ultrasonic immersion scanning is used as a technique for detecting defects inside the material. Normal beam (Longitudinal mode) inspection is used for detecting the four SDH of 5 mm diameter arranged at various depths. The Ultrasonic inspection data of **sample SG** is shown below:

As per the C-scan image shown above, the detectability of the defects in nodular cast iron is good across the thickness of the sample with good resolution.

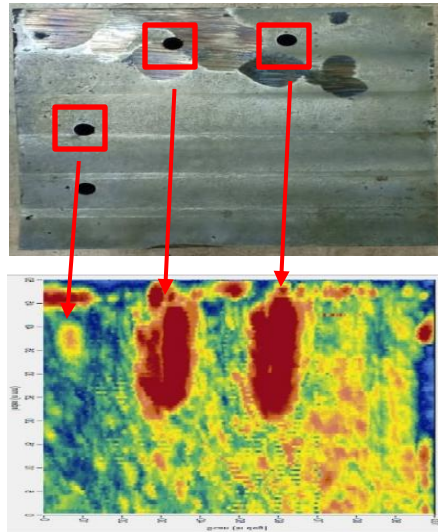
The inspection results of **Grey cast iron (G)** are as follows:

As per the C-scan image shown below, the detectability of defects using ultrasound in grey cast iron is limited to the subsurface defects and defects at larger depths are not detected. This shows the ultrasound is getting attenuated faster due to the grain structure of grey cast iron. Also, the noise levels in the A-scan are higher which is due to the reflection coming from grain boundaries.

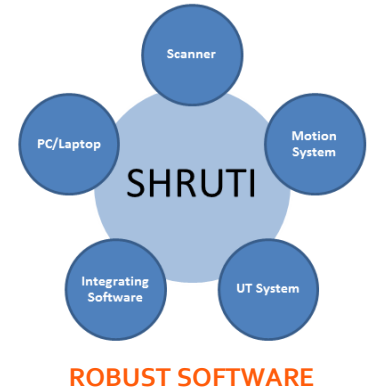
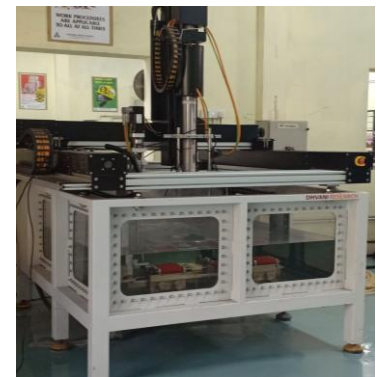
A typical scanning system

The system used for the inspection is **SHRUTI®**. Scanning High-Resolution Ultrasonic Inspection System is an indigenously developed customizable, automated, multi-axis robotic scanner. Along with ultrasonic probe, advanced data analysis (**extut®**) and image analysis packages SHRUTI facilitates easy inspection of samples and components.

**SHRUTI®** offers very high-resolution images of the test

coupon with very high scanning speeds. The complete instrument control is through the software. Skelton of the system is being built from lightweight aluminum extrusions which are upgraded to Stainless Steel for heavy-duty applications. All the electrical connections are rugged and properly routed following industrial standards offering very durable and reliable running.

The system employs rugged servo motors for motion requirements and had industrial standard safety interlocks.
