## IMMERSION ULTRASONIC IMAGING OF CONNECTING ROD SMALL END BRUSH INTERFACE SYSTEM

# Immersion Ultrasonic Imaging of connecting rod small end bush Interface-Application Note

A Dhvani Research Application Note

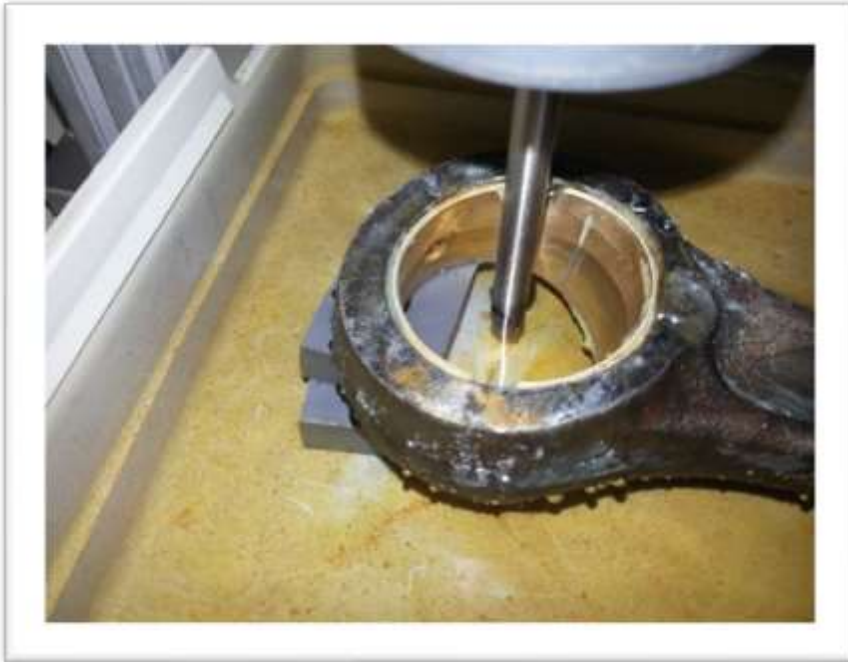
A typical Microscopic image showing Galling

friction and adhesion between the surfaces, followed by slipping and tearing of crystal structure beneath the surface. This will generally leave some material stuck or even friction welded to the adjacent surface, while the galled material may appear gouged with balled-up or torn lumps of material stuck to its surface. This problem of galling while fitting the small end bush will give rise to non-contact zones or lack proper contact zone along the circumference of the small end bush leading to localized mechanical and thermal stresses which causes catastrophic problems in the long run of the engine.
