EVALUATION ON CONTACT PATTERN OF BRASS BUSH AT THE SMALL END OF THE CONNECTING ROD USING IMMERSION ULTRASONIC INSPECTION

A Dhvani Research
Application Note

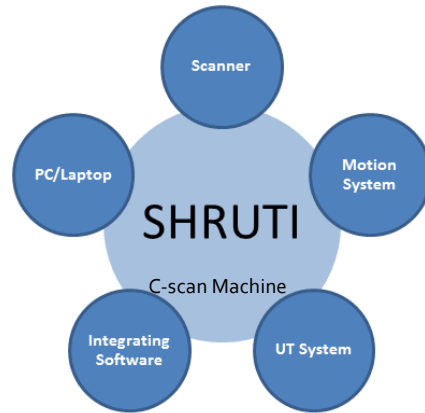
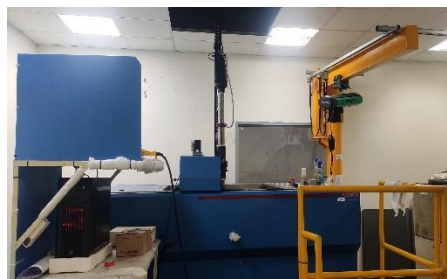
The system used for the inspection is **SHRUTI®**. Scanning **H**igh-**R**esolution **U**ltrasonic **I**nspection System is an indigenously developed customizable, automated, multi-axis robotic scanner with an Ultrasonic Probe. **SHRUTI®** offers very high-resolution images of the test coupon with very high scanning

speeds. The Z-axis & Rotary table control is through the software. Skelton of the Z-axis system is being built from Stainless Steel for heavy-duty applications. All the electrical connections are rugged and properly routed following industrial standards offering very durable and reliable running. The system employs rugged servomotors for Z-axis & Rotary table motion requirements and had industrial standard safety interlocks.

The system employs a pendent mechanism and auto cycle to reduce human intervention. The system is capable of running 24 x 7 with minimal human intervention. Both the pulse-receivers are

synchronized and interfaced with a central computer, which controls both the pulse-receivers and motion hardware at the same time and records the data to a central repository.
